Sustainability Case Studies

ENERGY MANAGEMENT: PLANT ROOM INSULATION

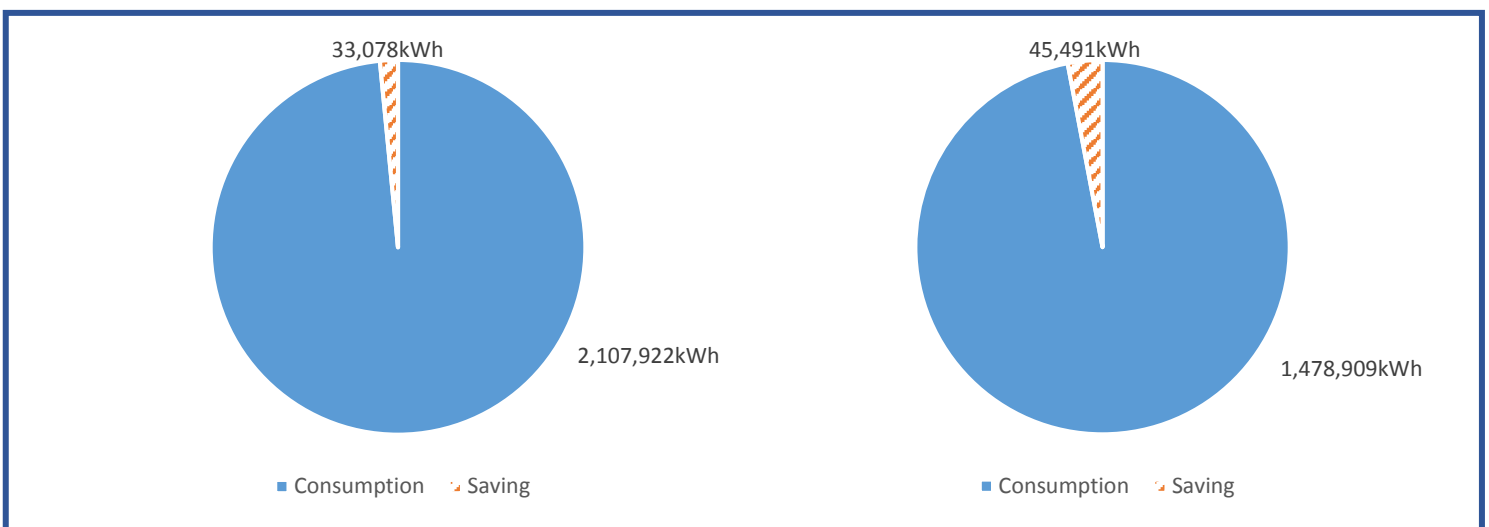
Figure 1: Crombie Hall Natural Gas Consumption (kWh)

Figure 2: William Guild Natural Gas Consumption (kWh)

Insulation of the Crombie Hall and William Guild plant rooms was completed during 2016. By insulating 7.11m² of pipework in Crombie Hall, it is expected that the quantity of natural gas required to heat the building will reduce by 1.54% and save 6.12 tonnes of CO₂ emissions. The insulation of 3.51m² of exposed pipework in the William Guild plant room is expected to reduce the volume of natural gas needed to heat the building by 2.98% and save 8.41 tonnes of CO₂ emissions.

Despite the relatively small reduction in natural gas consumption, these projects will result in estimated annual savings of £3630. The William Guild project will be paid back in less than 13 months and the Crombie Hall project will be paid back in just over three years.

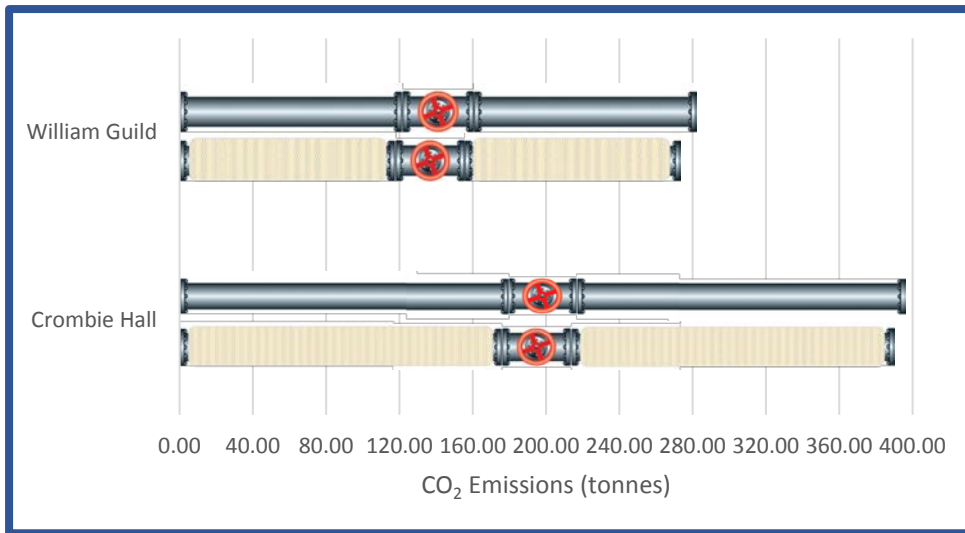
Figure 3: Heating Associated CO₂ Emissions (tonnes)

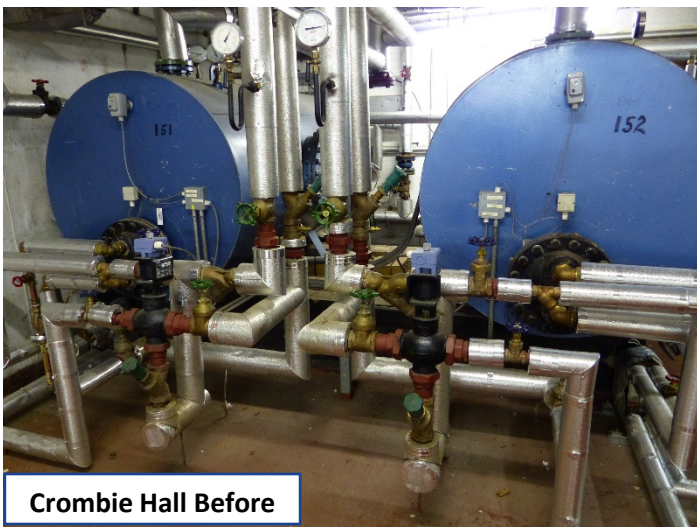
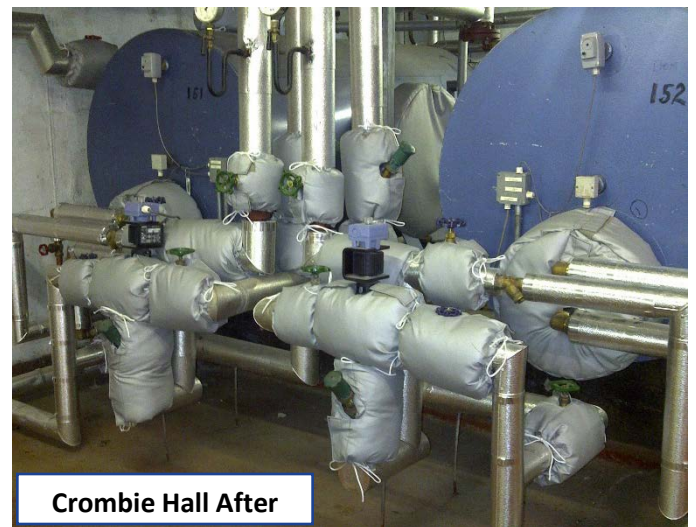
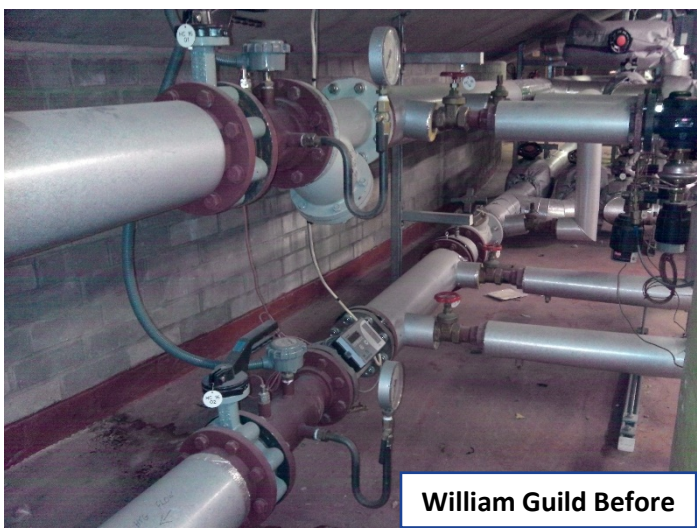
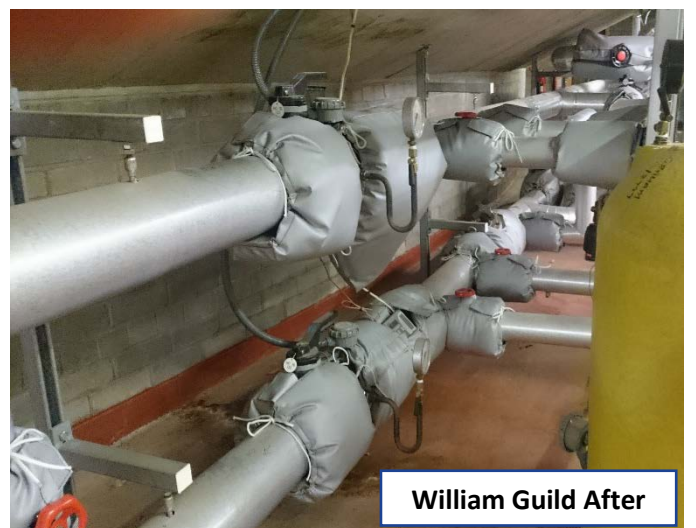
Insulation is often removed for maintenance and not replaced. Using custom made fastenings for the insulation, it is now easier to remove and replace during routine maintenance.

After measuring the exposed pipework in the Crombie Hall and William Guild plant rooms, insulation blankets were identified as the most cost effective solution. This option was chosen as much of the exposed pipework included valves and flanges that couldn't have been insulated through conventional methods
